**Electro Optical Components, Inc.**

# Effects of sterilization on silver halide fiber optic probes

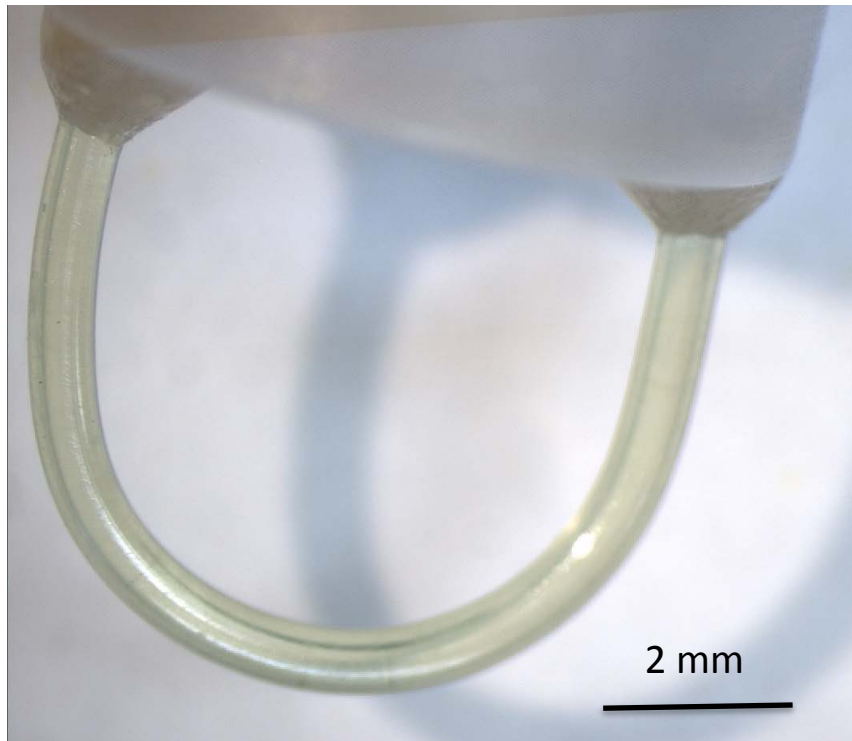
**Silver halide probe tip 1 from Sterrad® group before sterilization**

- A probe tip in the Sterrad<sup>®</sup> group became blackened at the two ends after sterilization cycle 1.
- The blackened effect was not observed in the remainder of the probes in the Sterrad<sup>®</sup> group.
- The epoxy resin, securing the fiber optic to the polymer mount, changed from a tan to a white color for all probes in the Sterrad<sup>®</sup> group.

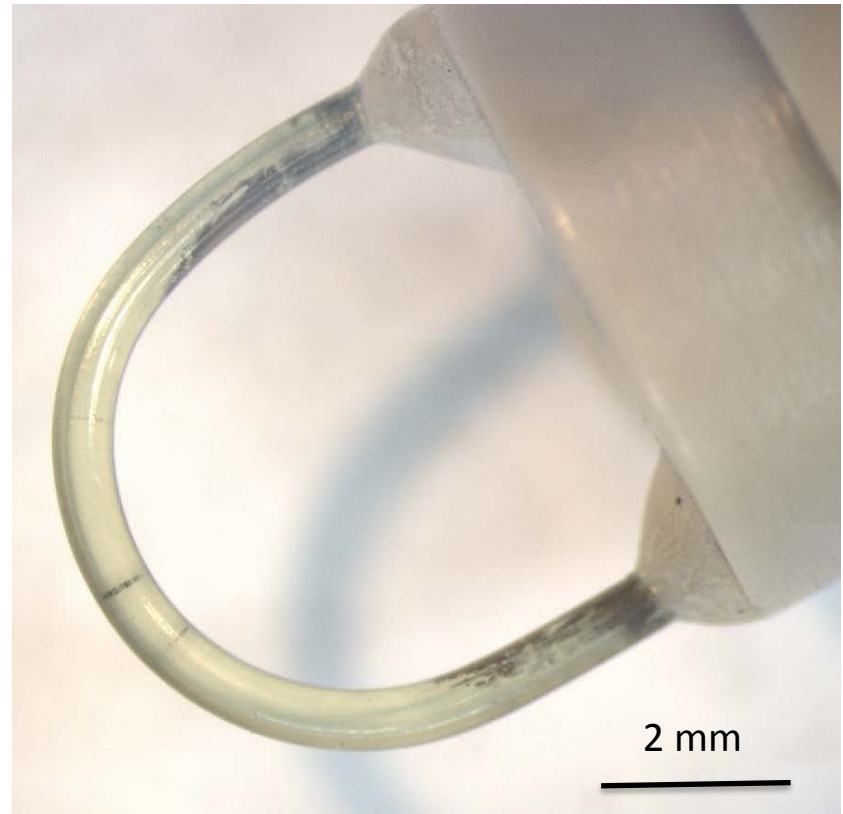
**Silver halide probe tip 1 from Sterrad® group after sterilization cycle 1**

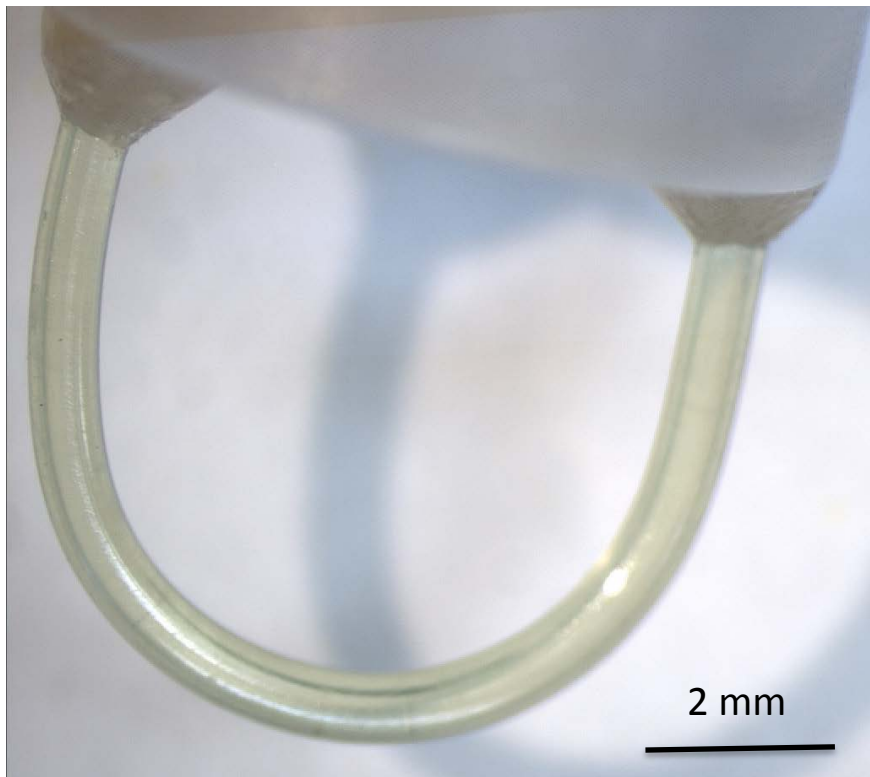
**Silver halide probe tip 1 from Sterrad® group before sterilization**

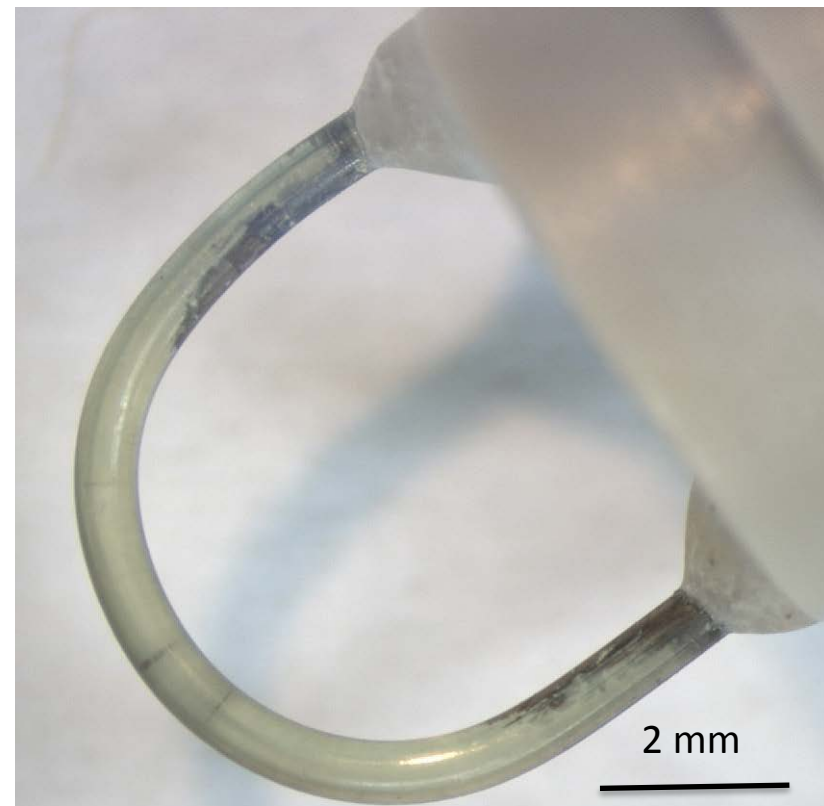
**Silver halide probe tip 1 from Sterrad® group after sterilization cycle 3**

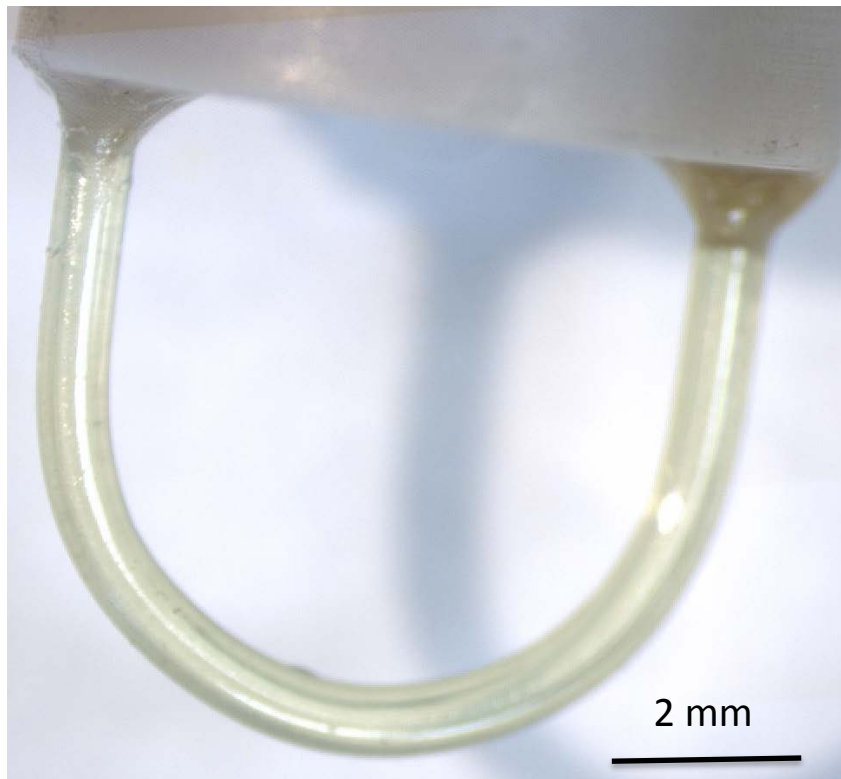
**Silver halide probe tip 1 from autoclave group before sterilization**

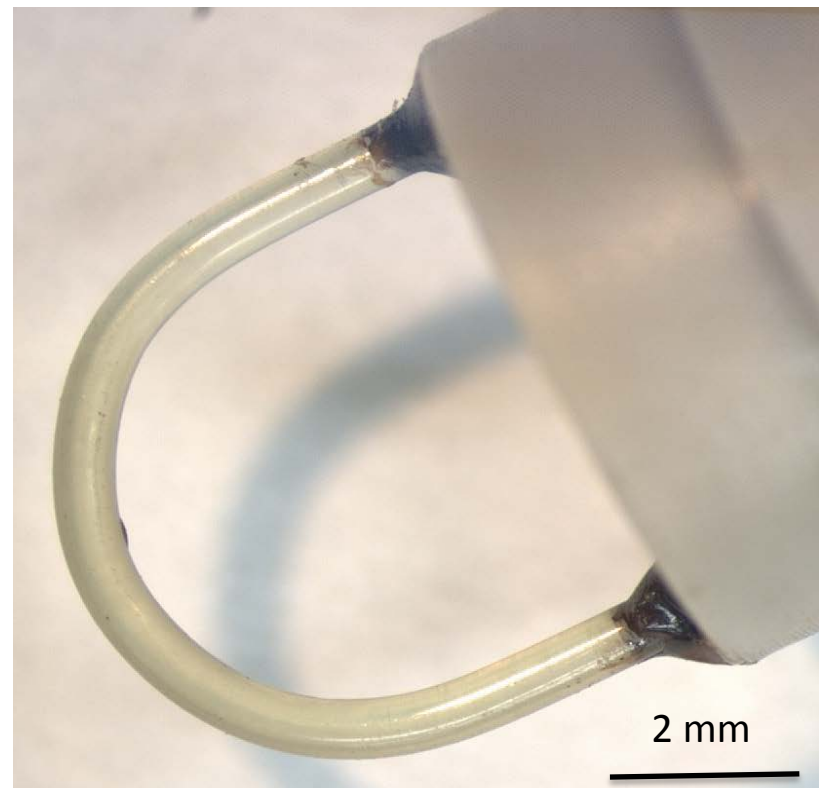
**Silver halide probe tip 1 from autoclave group after sterilization cycle 1**

In the autoclave group all probes appeared cloudy after the first cycle of sterilization and the epoxy resin changed to a dark brown color.

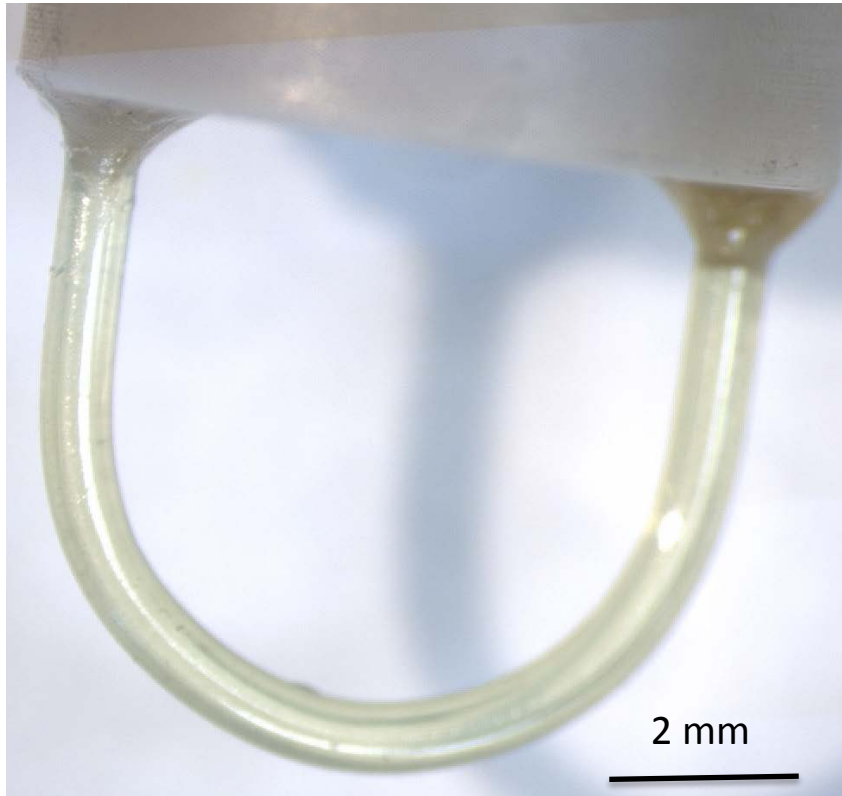
**Silver halide probe tip 1 from autoclave group before sterilization**

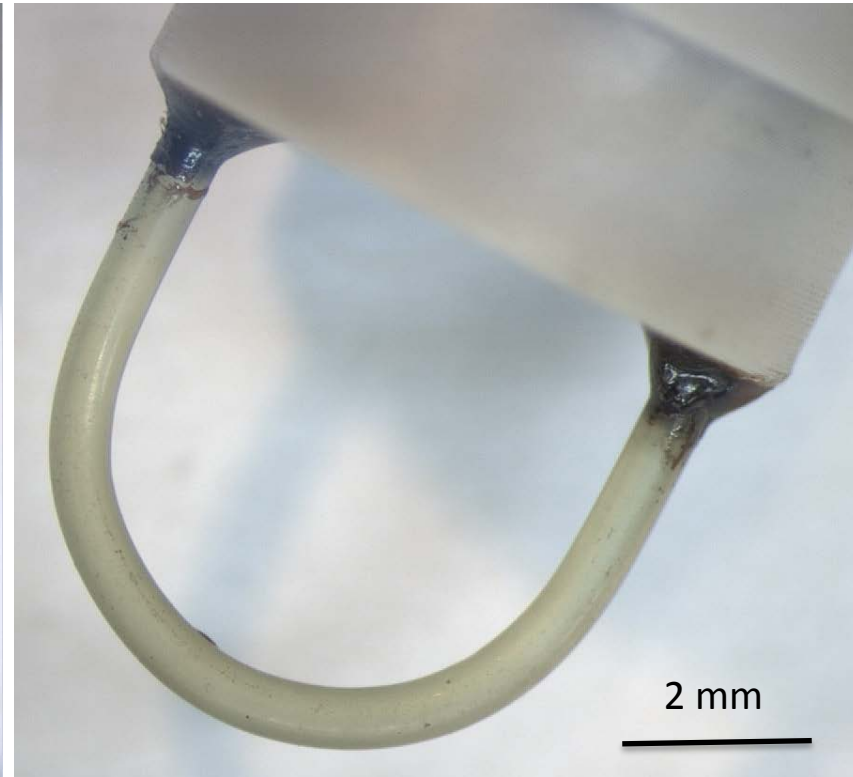
**Silver halide probe tip 1 from autoclave group after sterilization cycle 3**

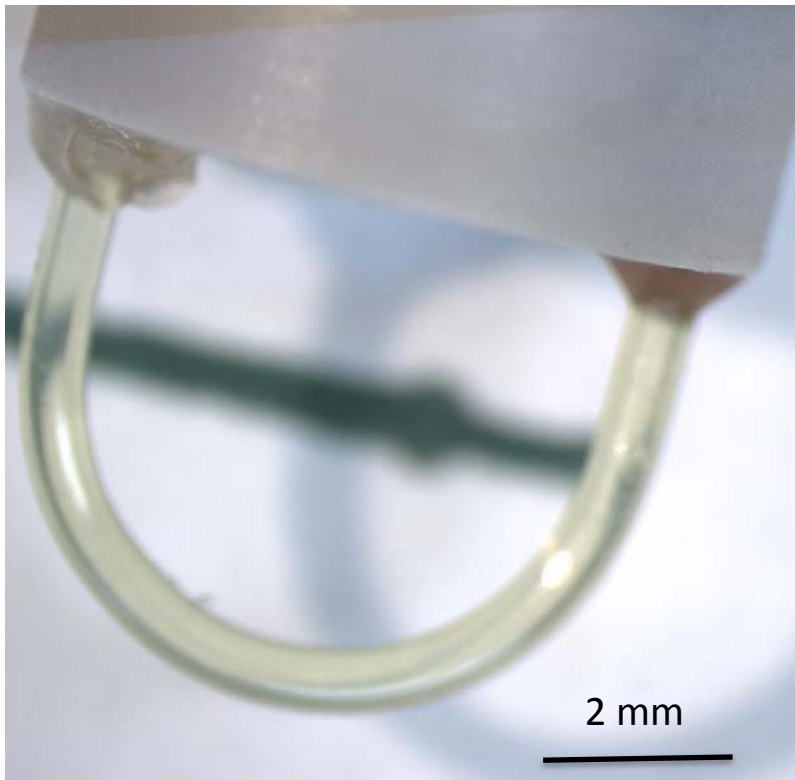
Silver halide probe tip 1 from control group before sterilization

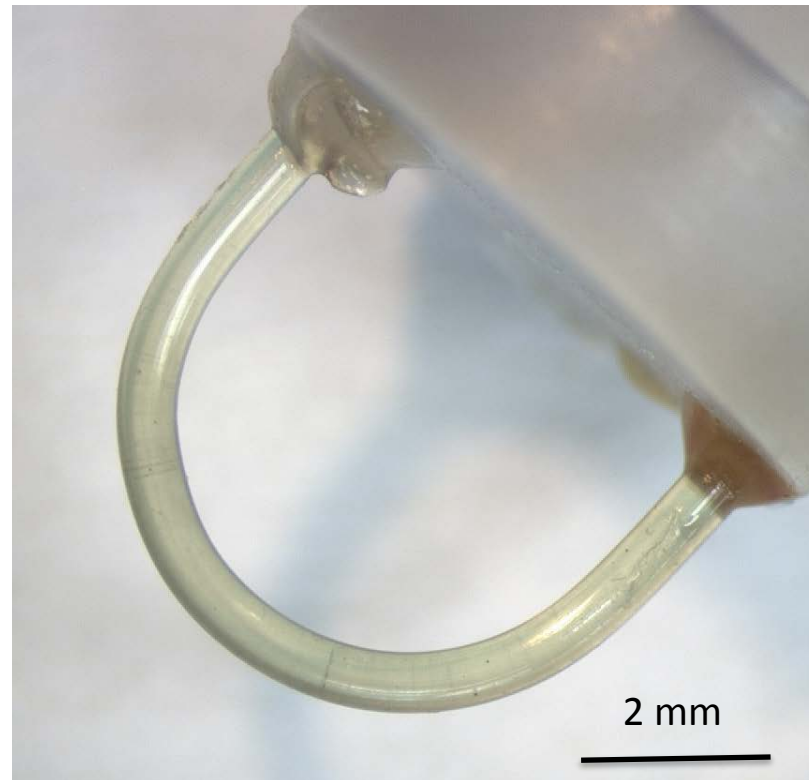
Silver halide probe tip 1 from control group after sterilization cycle 3

**There were no changes observed in the control group's probe tips for all sterilization cycles.**

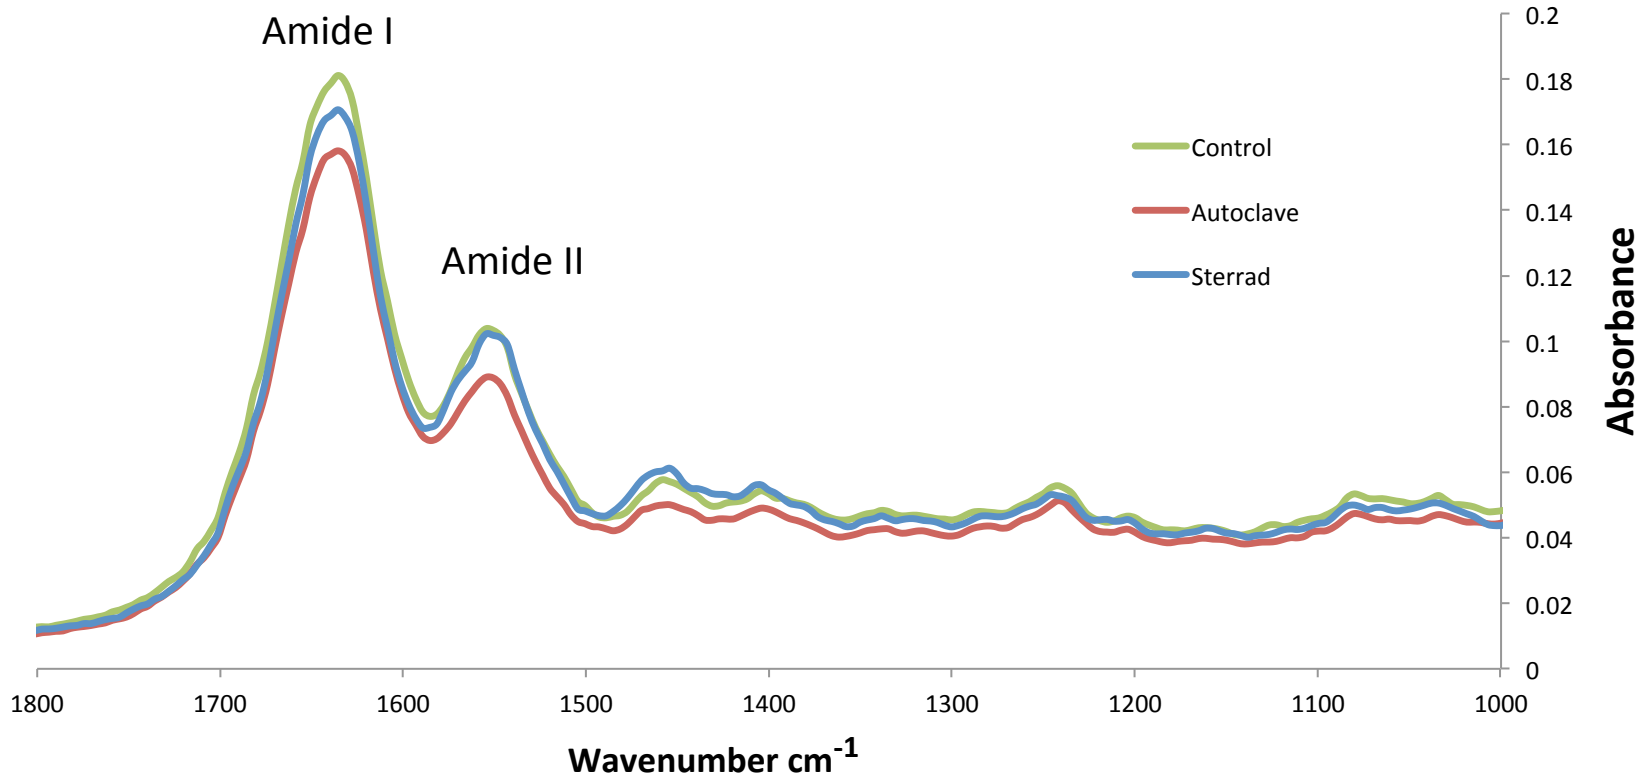
## Spectral overlay of bovine cartilage after sterilization cycle 1

The spectral overlay above of the Sterrad, autoclave and control group does not show any significant changes in the Amide I and II peak heights in bovine cartilage.

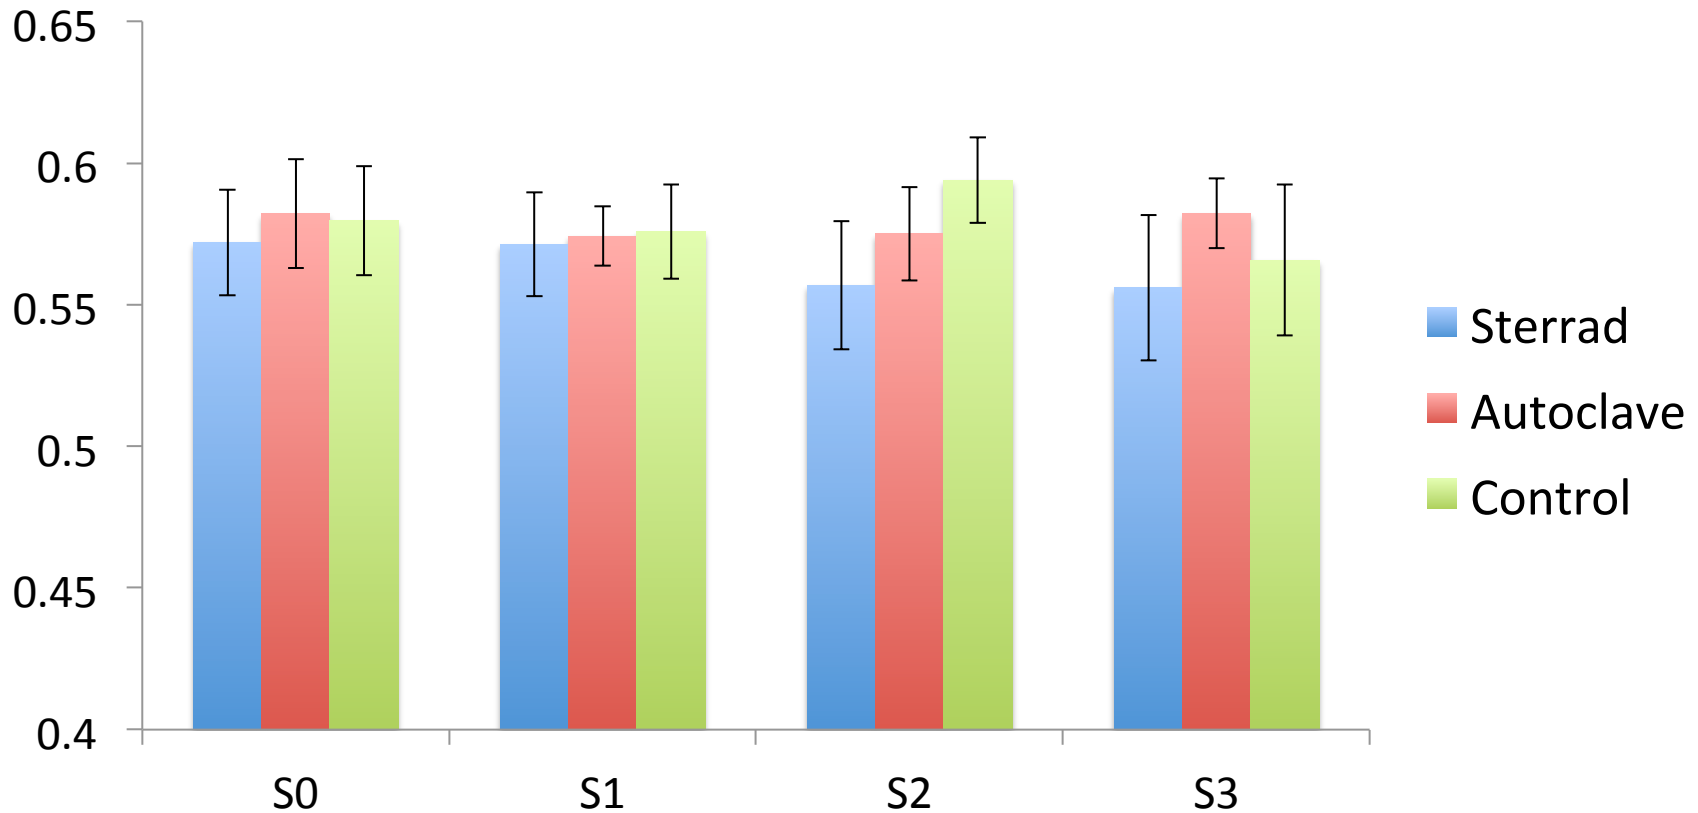
## Average Peak Height Ratio for Amide II/Amide I of Cartilage

There were no significant changes in the peak height ratio of the bovine cartilage sample after each cycle of sterilization. This trend was seen in the 95% ethanol, ATR standard and patellar tendon sample (data not shown). The data suggests that Sterrad and autoclave did not have a significant effect on the optical properties of probe tips.
